Management of City aquifers from anthropogenic activities, soil dynamics and challenges for the future: An example of the Windhoek aquifer, Namibia.

B.S. Mapani^a, U. Schreiber^b and A.F. Kamona^c

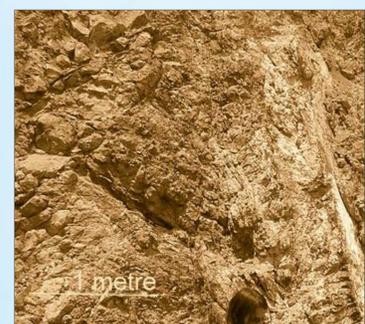
The Pahl Fault, Windhoek, showing a highly fractured disposition that characterizes the Windhoek aquifer.

Windhoek is built on a thin soil cover, making its highly fractured aquifer extremely vulnerable. As observed in the surrounding fault systems (e.g. Pahl Fault), nitrate leakage is occurring in these fractured zones. Development of new industrial enterprises (e.g. textile industry) around

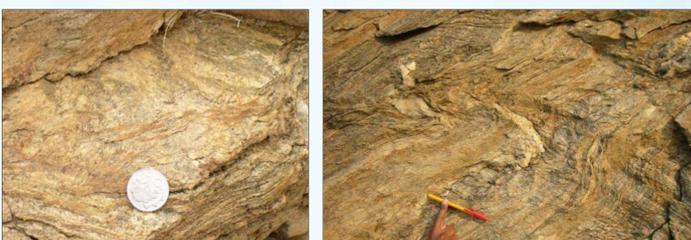
Cleavage (left) and compositional layering (right) within the Kuiseb schist. The soil yield from the locally deeply weathered rock is generally very low.

Vertical primary porosity and permeability in the Kuiseb schist is quite low; crucial to the porosity and permeability is the fracture pattern of the rocks and their schistosity. Groundwater is stored and transmitted along north-south trending faults cutting the urban area, and generating fracture zones. The Auas quartzite to the south of the city (far right) is the main principal aquifer, with the Kuiseb schist being secondary in nature; natural recharge to the aquifer is principally through the Auas quartzite. The water demand for Windhoek (above) shows a consistent sinusoidal curve for groundwater levels (Kirchner, 2001) - following years of excessive abstraction (dark bars), aquifer levels show a significant drop. The average storage capacity of the aquifer is 14.64 million m³/annum (GTZ-DWA (1993), but can reach up to 18 million m³/annum.
